发电机转子磁极耐压试验放电原因分析与处理

摘要:铜街子水电站 14 号机组因运行年限较久,公司决定对其发电机定子、转子进行升级改造,对 68 个磁极也全部进行更换。新磁极为东方电机公司生产,现场对发电机转子磁极进行组装时,在耐压试验过程中,分别发现有 4 个磁极存在放电现象,随即对发电机转子磁极组装前的单个耐压试验、组装后的整体耐压试验过程中发生的放电现象进行了分析比对,从而找出了其存在放电现象的原因,即因杂质过多而导致的放电,并有针对性地提出了有效的处理方法。同时,也对后续相关设备进行类似试验的方法提出了建议。

铜街子水电站位于大渡河下游,其 14 号水轮发电机组型号为 SF175-68/12800,单机容量为 150 MW,是由东方电机公司在 20 世纪 90 年代初生产的水电设备。该机组的定子出口电压为 13.8 kV,转子励磁电压为 400 V。

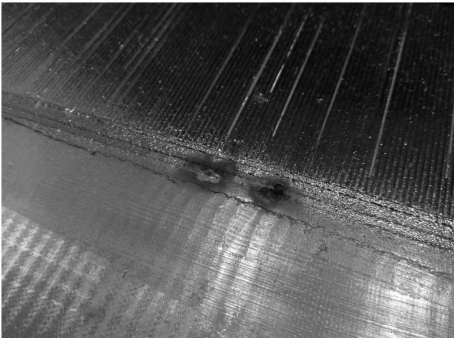
然而,在对安装后的 11 号磁极进行检查时,发现此次放电现象有别于一般的放电现象,它是磁极铁芯与磁极线圈的接缝处对磁轭进行放电,如图 1 所示。放电磁极对应磁轭上的放电痕迹示于图 2 中。

图 1 磁极上的放电点

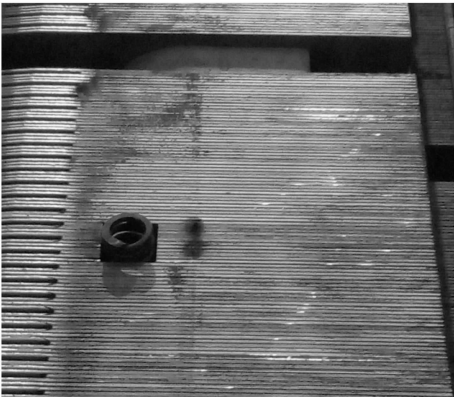
图 2 放电磁极对应磁轭上的放电痕迹

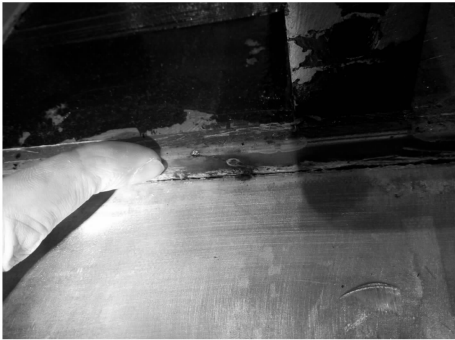
环氧板存在放电通道,如图 3 和图 4 所示。对磁极线圈与铁芯进行了检查,发现线圈内部的洁净情况较差,存在一定程度的粉尘及其他杂质(见图 5)。另外,在分解中还发现磁极线圈与铁芯之间的密封情况比较差,存在一定的间隙;随后,在对发生问题的另外 2 个磁极进行分解检查的过程中,也发现了类似的问题。

图 3 线圈与铁芯间环氧板上的放电通道

综上所述,通过对磁极实施分解检查,不难发现,此次放电现象的发生,最主要的原因是磁极在生产过程中并没有执行严格的现场洁净条件要求,从而导致磁极铁芯与线圈之间进入了一些金属性杂质而产生的放电现象。另外,磁极铁芯与线圈之间存在一定的缝

(1) 对磁极进行分解,用酒精全面清洗环氧托板、线圈及铁芯等部件。

(2) 对以上绝缘件打磨部位补刷室温固化环氧胶;去除磁极铁芯的极身部位,围包 $\text{Nome} \times 410$ 型纤维纸。

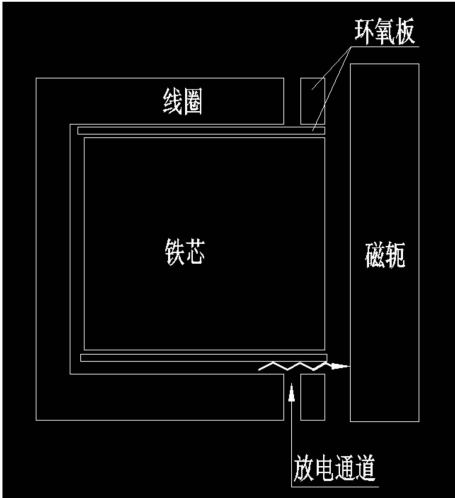
图 4 放电示意

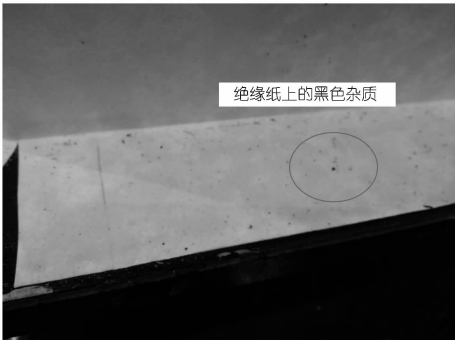
图 5 磁极内部杂质

隙,由于没有对这些缝隙进行严格的密封,因而在后续安装或者运行的过程中,使线圈内部进入异物杂质或碳粉的概率增加,从而对投运后的机组产生极大的安全隐患。

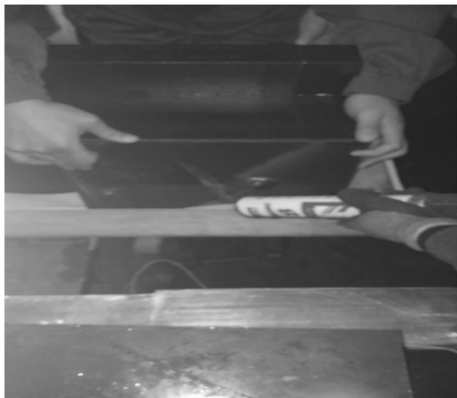
图 6 对线圈密封

(5) 按图 6 所示,用硅橡胶速纳星 68 封堵磁极铁芯极身与外托板之间的间隙。

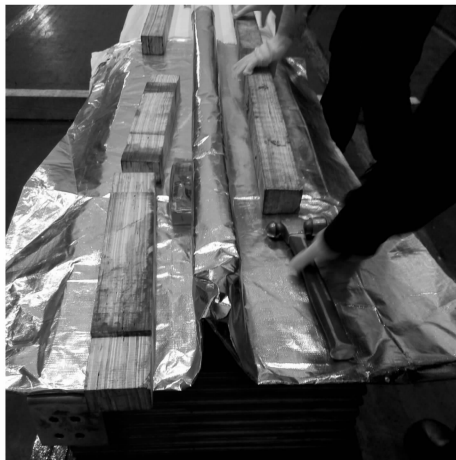
正如本文前面所述,转子磁极在安装前的耐压试验过程中并没有发现这一薄弱点,而在磁极挂装完成以后才暴露出来,这就表明,在安装之前进行磁极耐压试验时并没有包含磁极对磁轭间的绝缘薄弱点。前文提到的 19 号磁极,在对其实施耐压试验的过程中听到放电声音以后,试验人员即刻中断了试验,并对磁极进行绝缘测试,结果发现绝缘电阻值为 $2 \text{ M}\Omega$;但是在将磁极拔出以后,再次对该磁极进行绝缘测试,此时发现绝缘电阻值达到了 $70 \text{ M}\Omega$ 。为此试验人员在磁极铁芯与线圈的接缝处紧贴了一张锡箔纸,再次测量绝缘后,结果发现绝缘电阻值为 $5 \text{ M}\Omega$ 。由此不难得出磁极绝缘薄弱点所在。

图 7 完善后的耐压试验方法

(7) 在磁极线圈铜排上表面靠近铁芯侧,用硅橡胶速纳星 68 封一圈后,再装磁极内托板,完成以后,按图 7 所示,再用硅橡胶速纳星 68 封堵内托板与磁极铁芯之间的间隙;在封堵的过程中,注意磁极两端头装线圈压块的部位,在此处也需要先使用硅橡胶速纳星 68 进行封堵,然后再安装线圈压块。

综上所述,建议在后续开展的相关试验中可采用本文所描述的试验方法来试验,从而确保能够更加全面地反映被测试品的绝缘状况。
